Technical Support Document
For Record Of Decision
Tatalina, AFS

INSTALLATION RESTORATION PROGRAM
TECHNICAL SUPPORT DOCUMENT
FOR RECORD OF DECISION
TATALINA AIR FORCE STATION
LRRS SITE

Prepared By
Woodward-Clyde Consultants
701 Sesame Street
Anchorage, AK

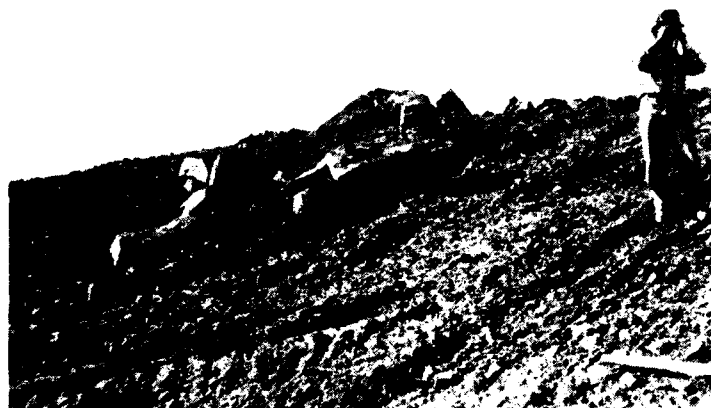
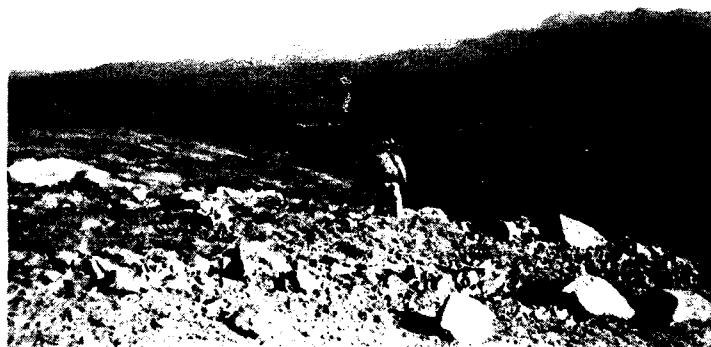
Figure 4

Spill/leak Nos. 6 and 7 (site 1) were recorded near an Upper Camp garage. The garage was recently demolished and the area covered with fill. No evidence of contamination remains. Two dumps also exist at the Upper Camp (site 5, Figure 4). Both sites have been cleaned and graded; no contamination or debris was observed.

Upper Camp Dump
Tatalina AFB

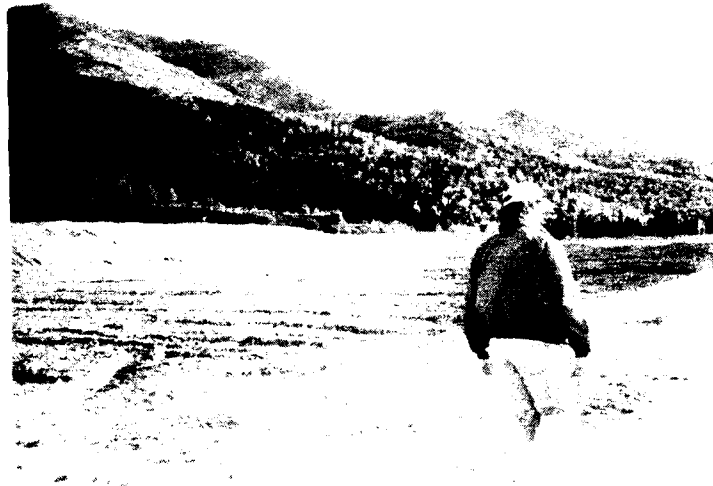
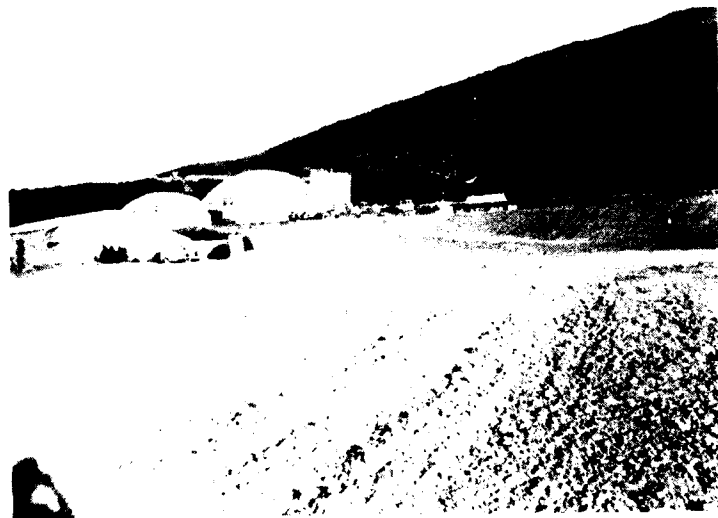
Figure 7

Two waste accumulation areas (sites 7 and 8) and a contiguous waste accumulation area and landfill (site 10) are located in the Lower Camp. All three sites have been closed. Sites 7 and 8 were associated with the old station complex which has been demolished. The sites were covered with over 1 m of fill, and no evidence of contamination was observed (Figure 7). Site 10 has also been closed and covered over. This landfill is now being used as a playing field.

Waste Accumulation Areas
Tatalina AFB

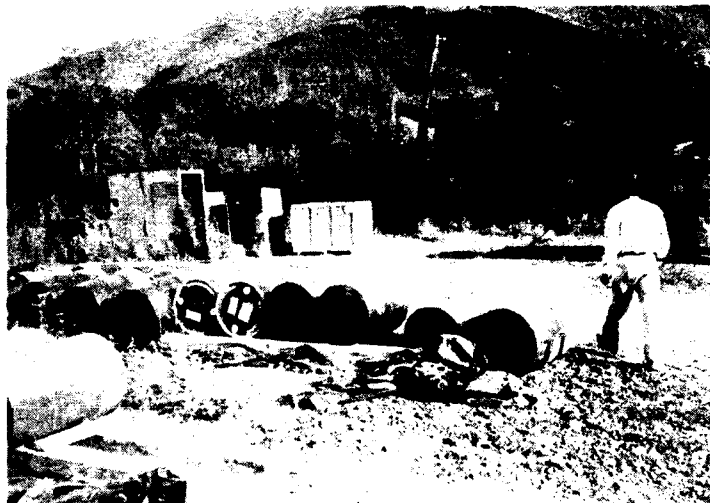
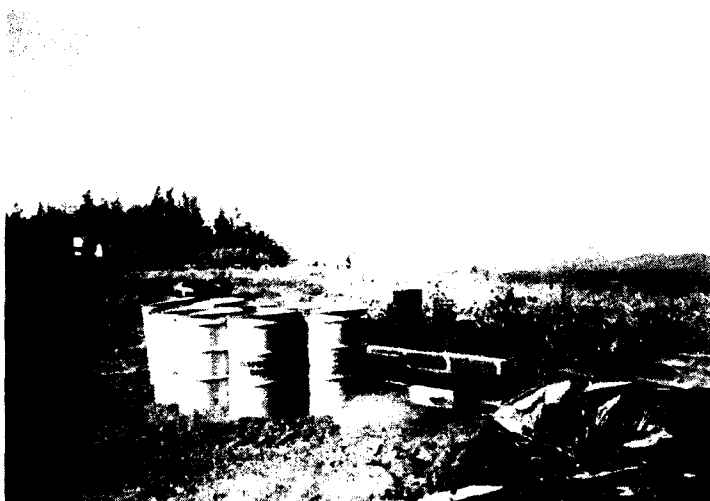
Figure 8

Sites 4 and 11 are the landfill and the active waste accumulation area, respectively. The waste accumulation area has evidence of a few minor spills, seen as dark stained soil one to several feet in diameter. Dozens of barrels are stacked at the area awaiting shipment off base (Figure 8). No vegetative stress was observed in the area. The active landfill exhibited no signs of contamination and appeared to be properly operated.

Active Waste Accumulation Area
Tatalina AFB

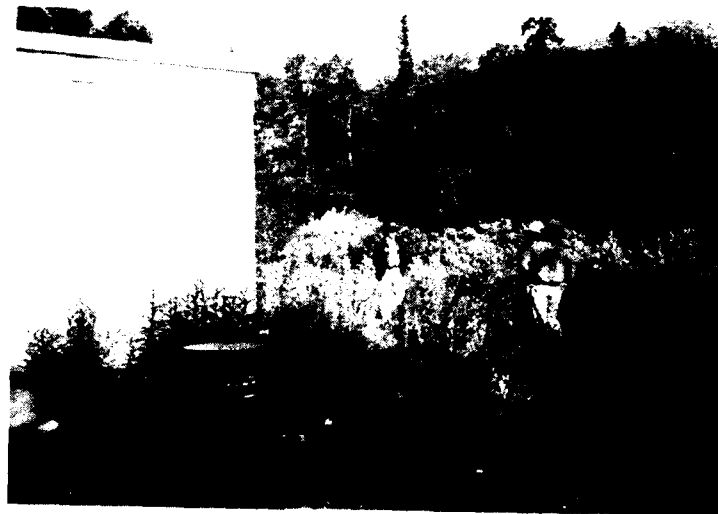
Figure 9

The survey team also inspected the water gallery at Tatalina AFS (see Figure 9). This was not identified as a "site" in the Phase I report (Eng. Sci 1985).

Water Gallery Pumphouse
Tatalina AFB
